Principal Investigator Joe Elmer
Senior Accident Investigator Karen Butler
Region Director David Barrett / Allan Beshore
Date of Report 8/10/2015
Subject Failure Investigation Report – Magellan Pipeline Company, LP – Other Accident Cause

Failure Investigation Report – Magellan Pipeline Company L.P. Breakout Tank Leak

Failure Date 11/22/2012

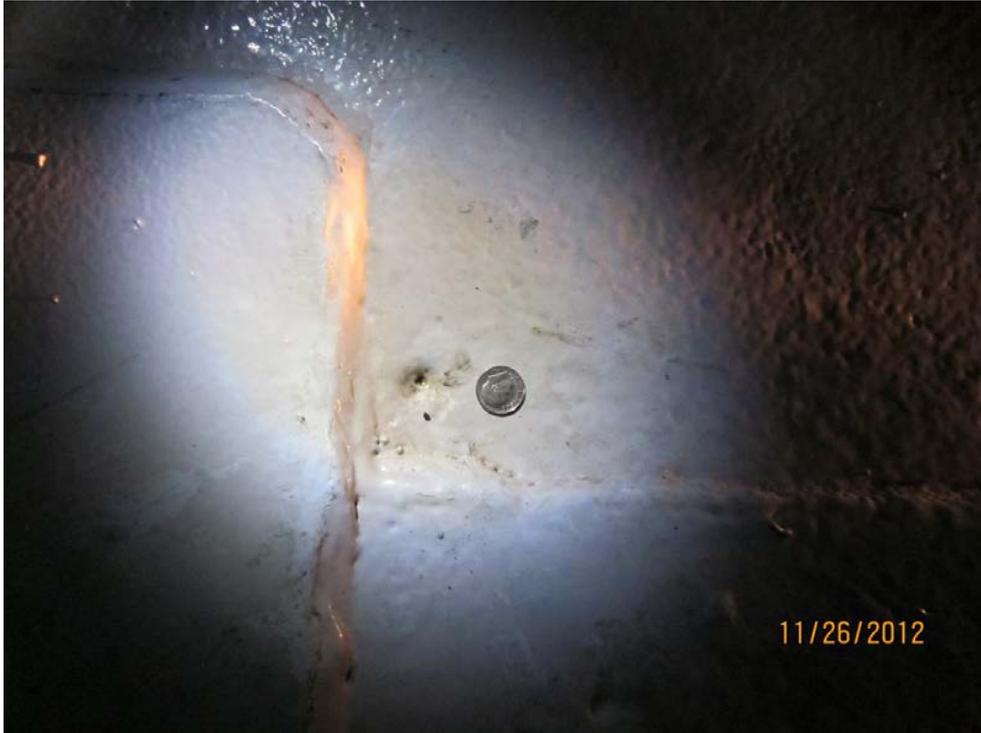
On November 24, 2014 the tank floor was cleaned and a through wall hole was discovered in the bottom of the tank. The hole was located near the south entrance .

The failure analysis performed by Kiefner and Associates did not identify a specific cause of the hole in the bottom of the tank. While conclusive evidence does not exist to determine the exact cause of the hole, it is strongly suspected that a leak at the coupling joint in the abrasive blasting equipment hose caused grooving in the floor in three areas and created the hole that caused the leak.

Visual indication of the through-bottom hole, 11/26/2012
(Magellan provided the photograph)

On November 29, 2012, HMT Inc. performed a vacuum test on all bottom and corner welds. No additional through bottom holes were identified. A 20-inch by 20-inch section was cutout that contained the hole in the floor and the section was sent to Kiefner and Associates for analysis. The damaged section of floor was repaired in accordance with API 653 and inspected by an API 653 inspector.

Corrective action taken: The internal epoxy lining specification has been updated to include wording that requires a protective sleeve be installed over all blast hose connections that come in contact with the blast surface. The specification requires that the fittings and protective sleeve be inspected before and after blasting activities to ensure the connection(s) are intact. If damage is found to the protective sleeve or hose connections that would be indicative of an abrasive leak, the blast surface will be visually inspected for damage.

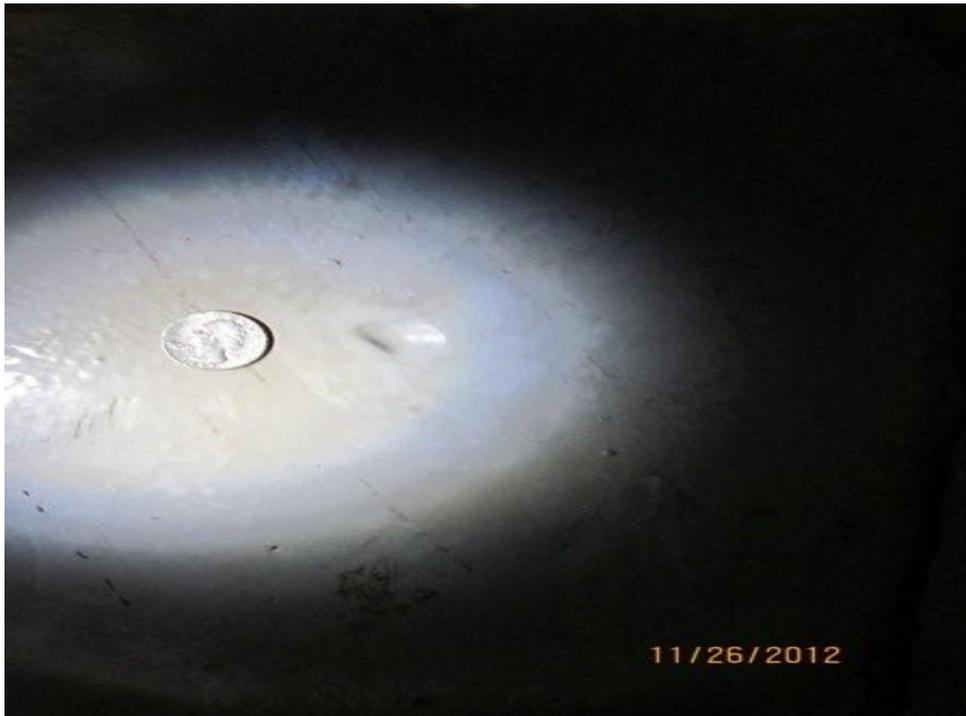
Visual indication of defect in close proximity to the hole, 11/26/2012
(Magellan provided the photograph)

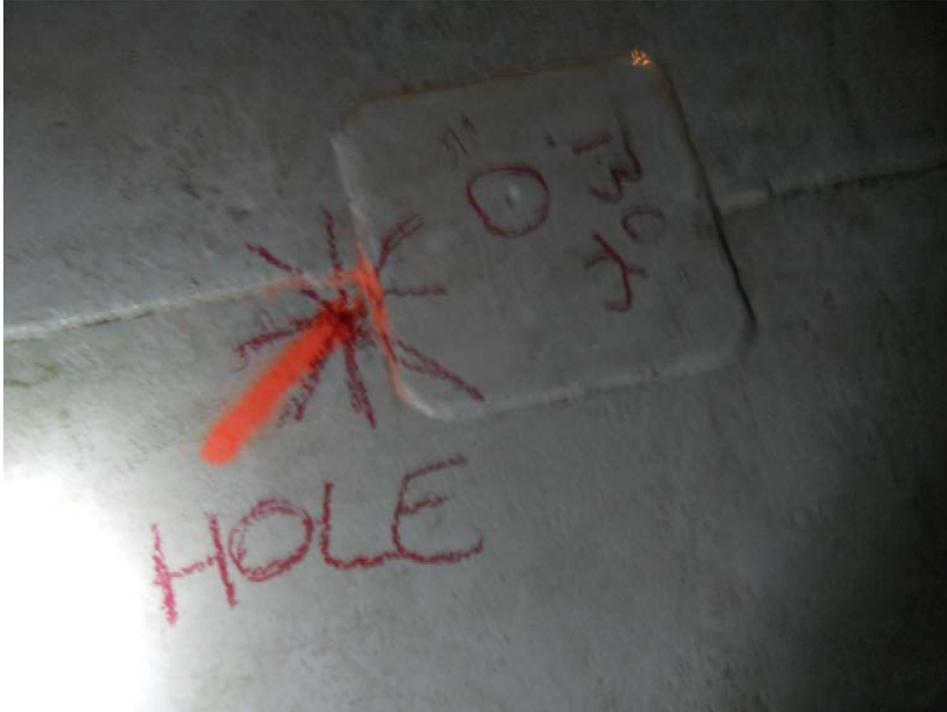
Visual indication of hole and the defect in close proximity to the hole, 11/29/2012. The patch was installed as part of an OOS inspection in 1997.

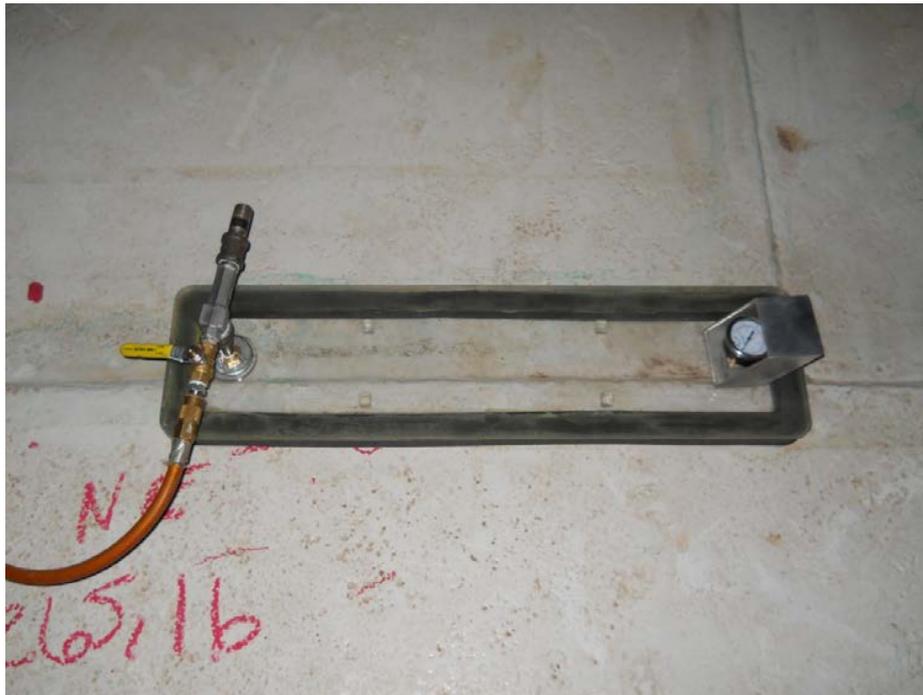
Example of vacuum box testing of the bottom welds conducted on 11/28/2012.

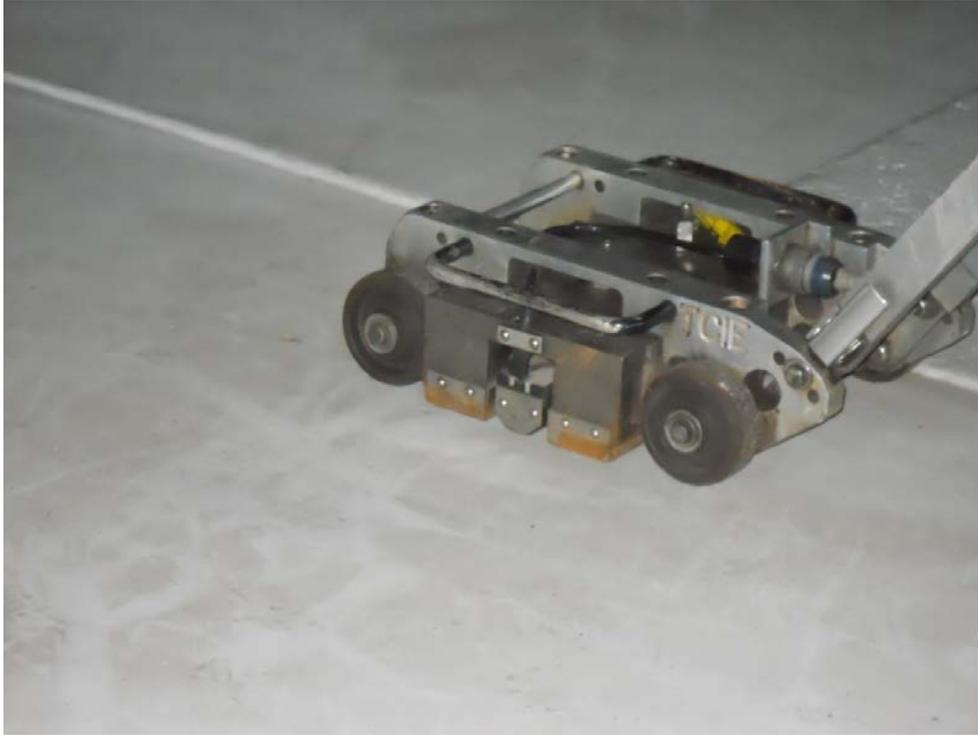
On November 28, 2012, Tank Consultants, Inc. performed a magnetic flux exclusion (MFE) scan on the entire floor. No additional through bottom holes were identified.

Example of MFE scanning on 11/28/2012.
(Magellan provided the photograph)
